ENGINEERING ANALYSIS
OF THE
RUSSIAN T34/85 TANK

SEPTEMBER, 1951

CIA Information Report
Number 00-T-00061

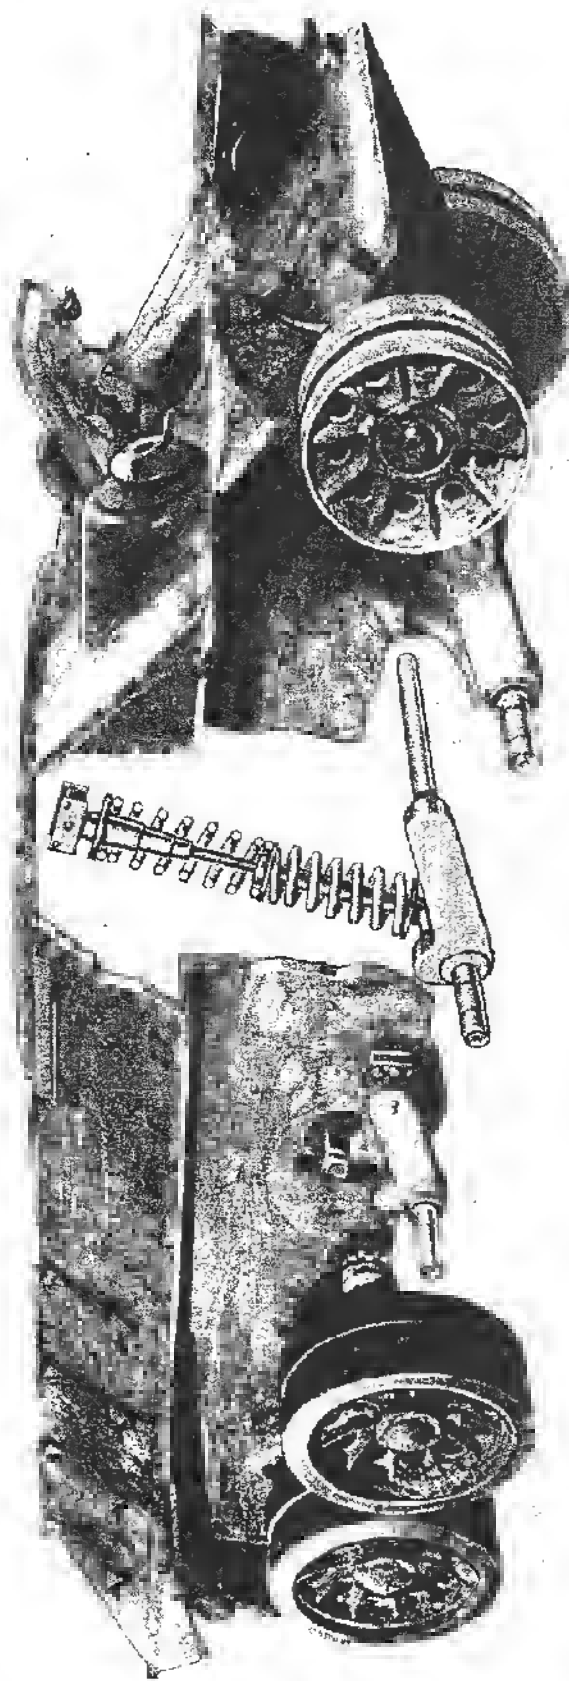
1800 f - HULL, CUT-AWAY VIEW SHOWING SUSPENSION

The two front suspension systems differed from the others in that the two coil springs were not in series but were concentrically arranged and were inside of the hull, rather than in housings which were welded to the hull. The coil springs were guided by a rod which was pinned to an arm splined to the suspension arm shaft. Clearances between the rod eye and the splined arm were not adequate, and bending of the guide rods accompanied by excessive wear had occurred.

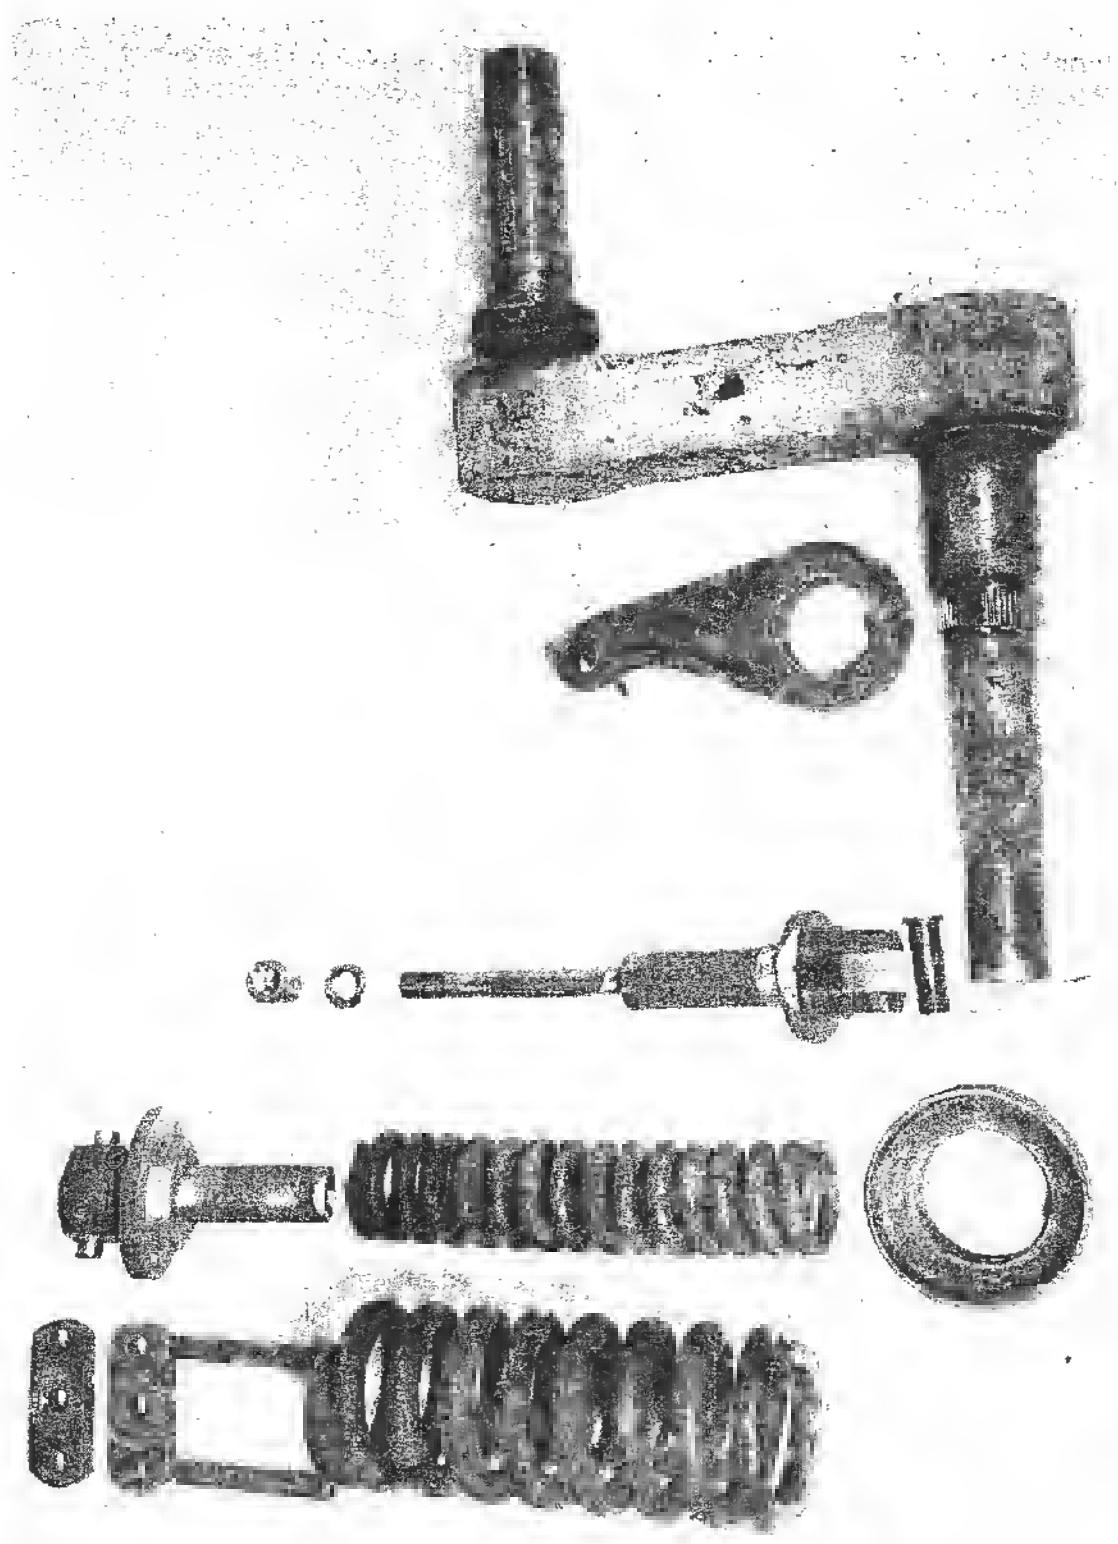
1301.0 - FRONT SUSPENSION ASSEMBLY

Yet a failure to machine sufficient clearance at the clevis root of the front suspension spring arms had not been caught by inspection. As the result, both front suspension spring guide rods had been bent and had worn severely. The sticking of these bent rods in their bushings could have caused loss of track tension and consequently loss of track. It is not known whether the track had actually been lost before the tank was captured.

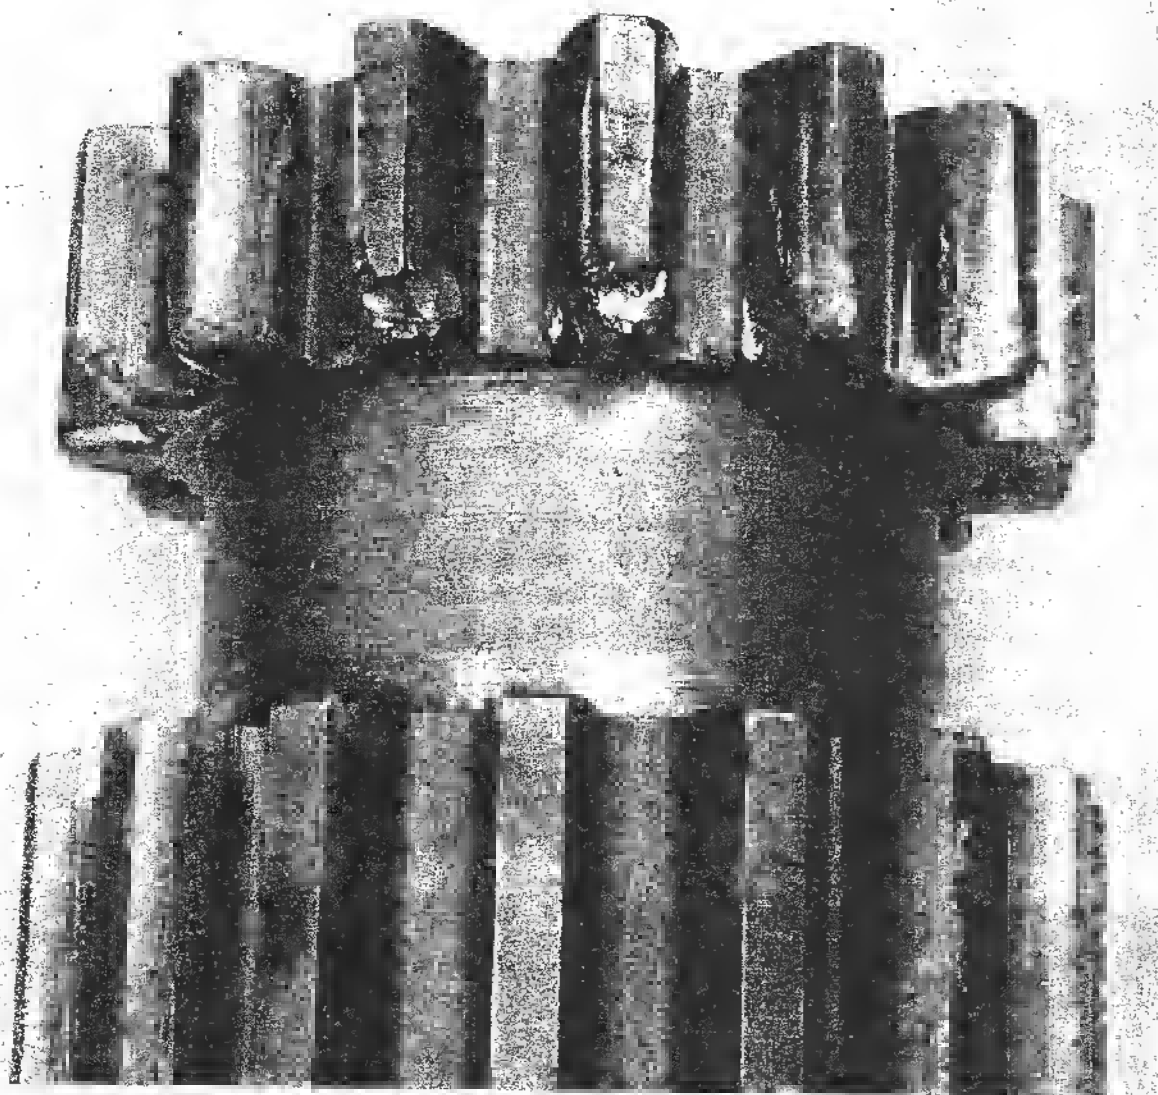
0702.5.6 a - REVERSE IDLER GEAR CLUSTER

The reverse idler was upset to form two gears in a cluster so that the flow lines were bent to form the tooth section of each gear. It was machined all over, carburized and hardened. The gear was shot blasted and the finish grind operations performed. The finish ground bore of the gear, which acts as a bearing seat, was file hard. The chamfered edge of the 15 tooth gear is battered and worn and chipped. The base of the tooth has a heavy groove worn on a taper starting at the edge of the tooth. The 16 tooth gear has grooves worn the full length of the tooth at the base. Photograph 0702.5.6 a

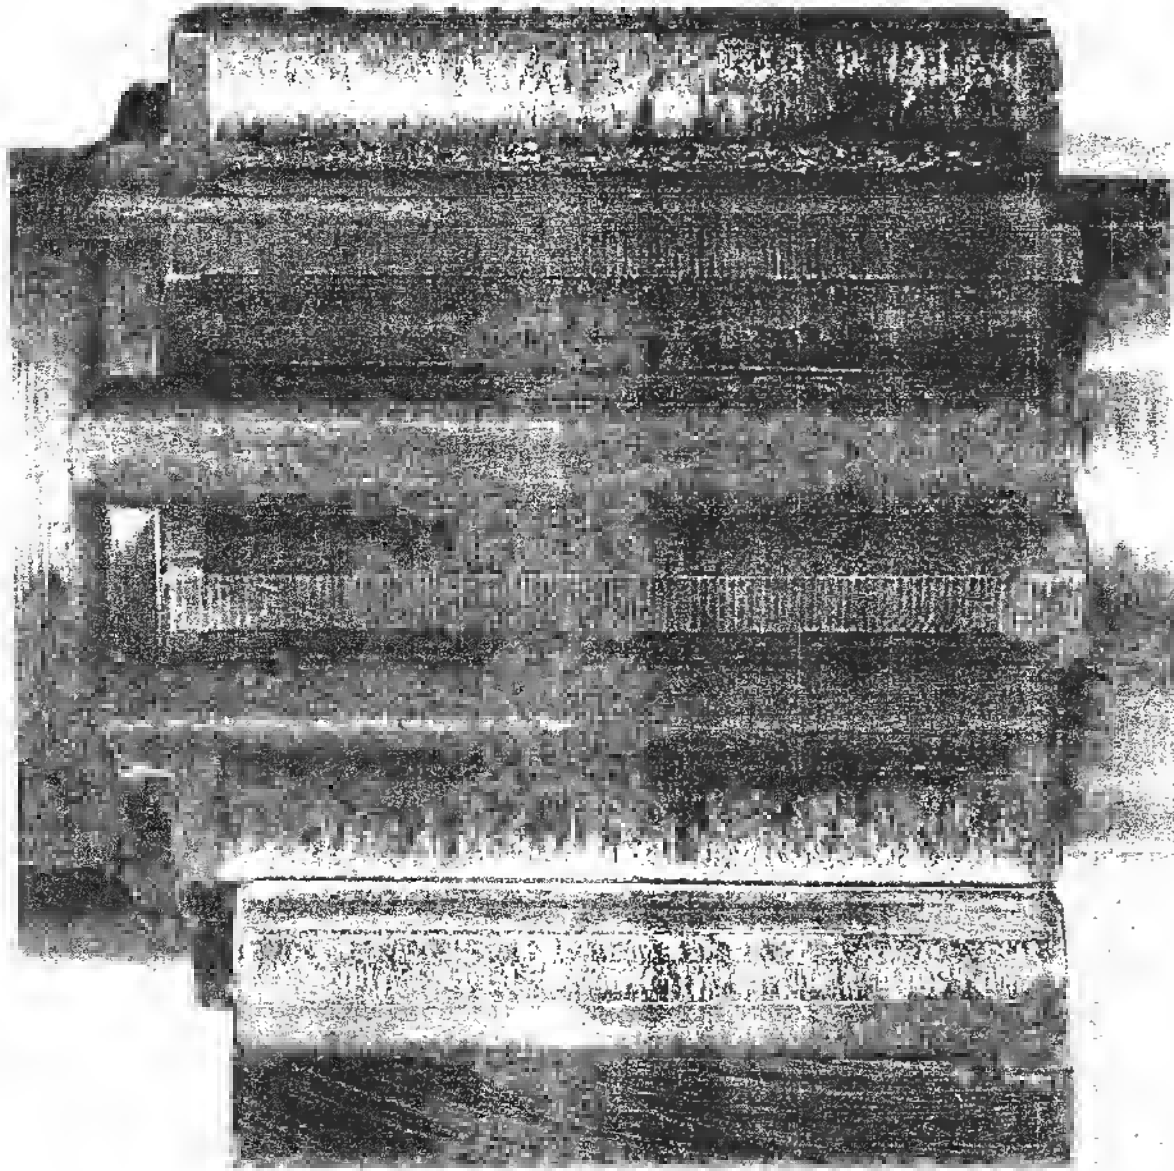
1008.4 - FINAL DRIVE PINION AND BULL GEAR SECTION

The final drive pinion was forged from Krupp steel in such a manner that the flow lines show the stock bent to form the tooth section. The analysis is shown in Table VIII. The pinion was machined, carburized all over and hardened. It was then shot blasted and the finish grinding operations performed. The teeth were worn and pitting had occurred at the bottom of the tooth face. Photograph 1008.4

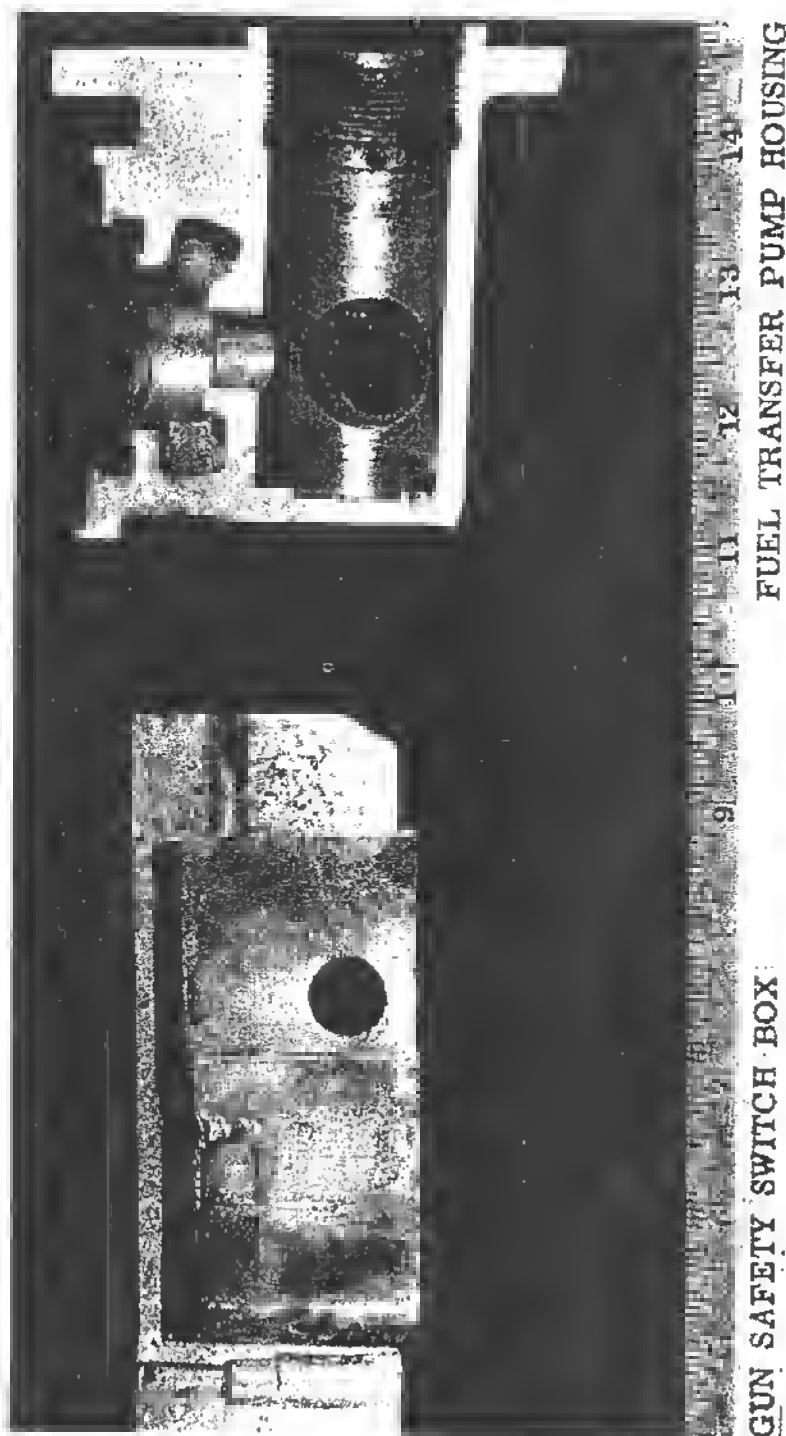
6443 - MACRO SECTIONS OF T34 COMPONENTS

MICROSTRUCTURE: Copper - Aluminum and Cu-Fe-Mn-Al constituents - Plus a brittle phase in which numerous fine cracks were noted and oxide inclusions.

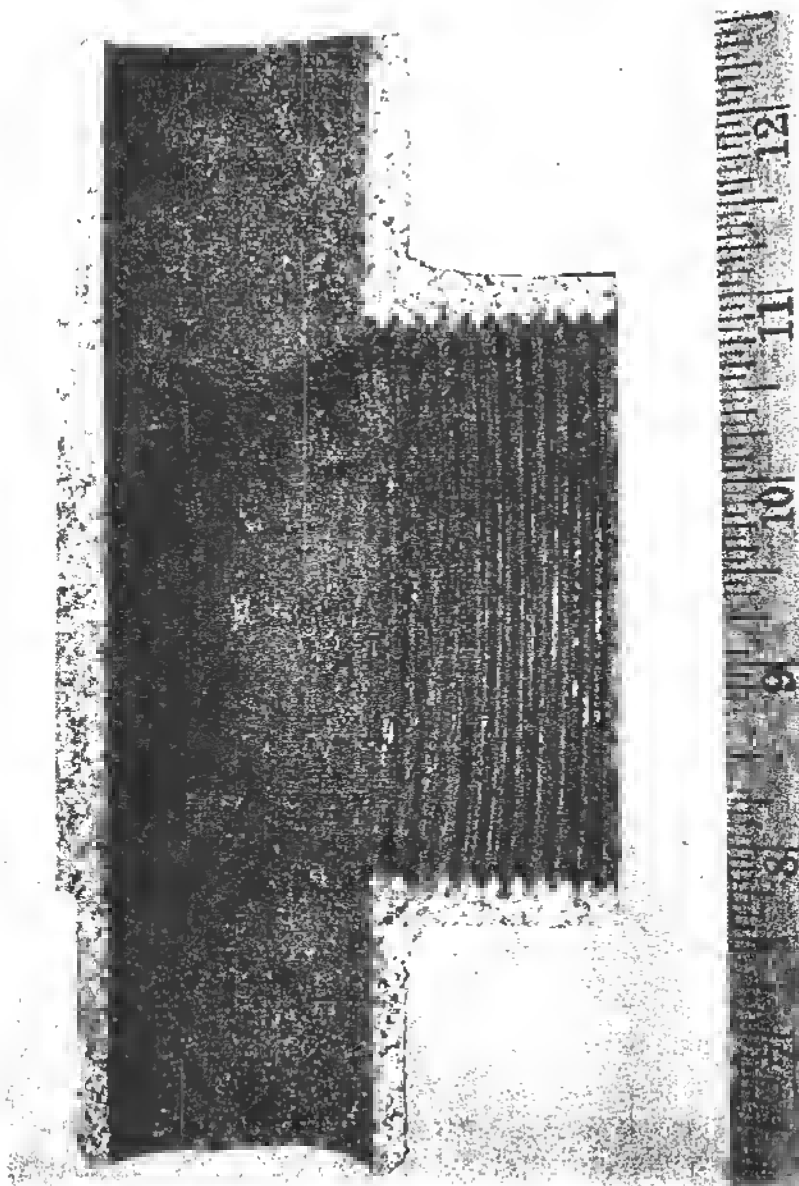
6433 - MACRO SECTION OF WATER FILLER AND PRESSURE
CAP HOUSING

MICROSTRUCTURE: Heavy intergranular attack thru Cu-Al and some un-
identified constituent in form of Chinese script. This appears to have been
a poor application for this high zinc alloy.
